TECHNICAL BULLETIN

AHB SYSTEM 8 and 21 SERIES PREAMPS

IMPROVEMENT TO RELIABILITY UNDER FAULT CONDITIONS

SYSTEM 8/ 2I SERIES INPUT PCB MODIFICATION

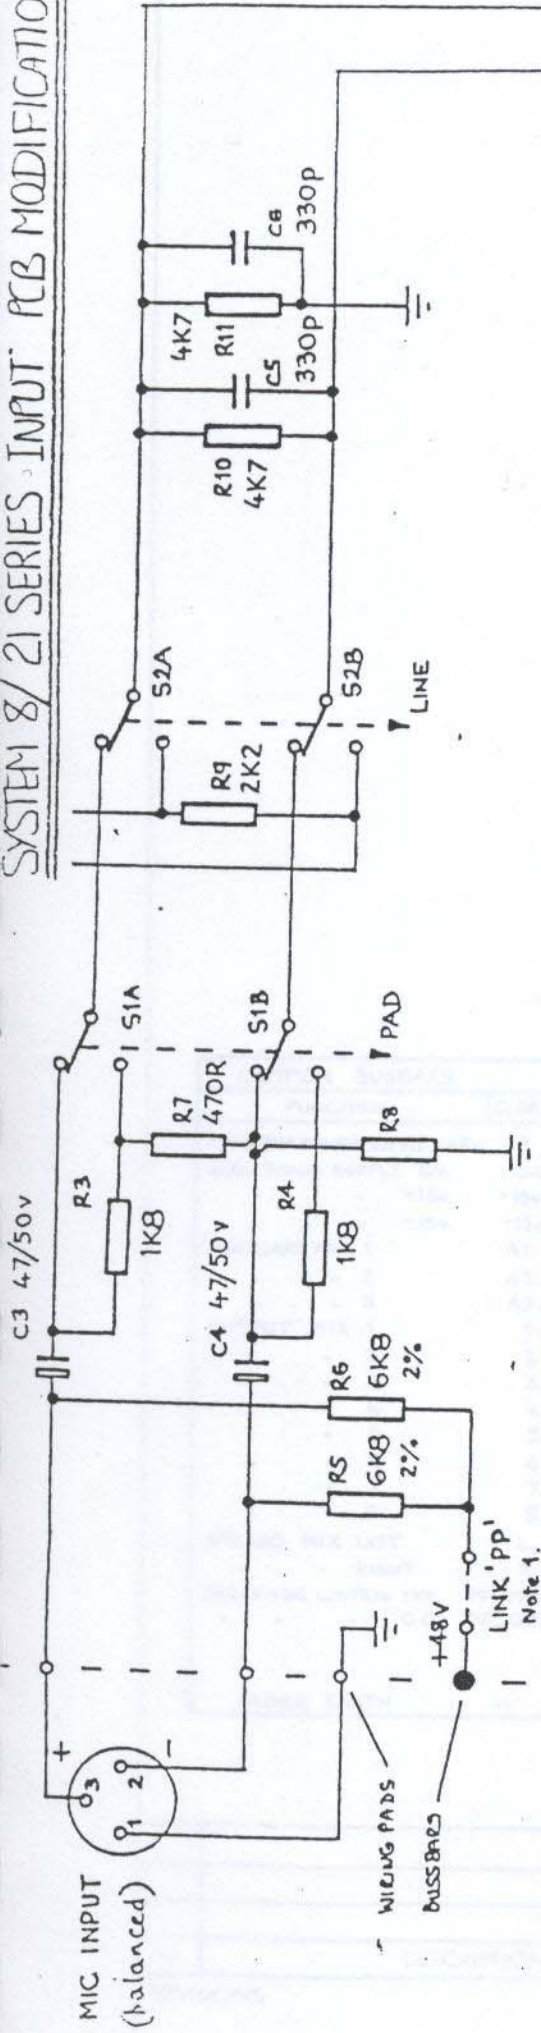
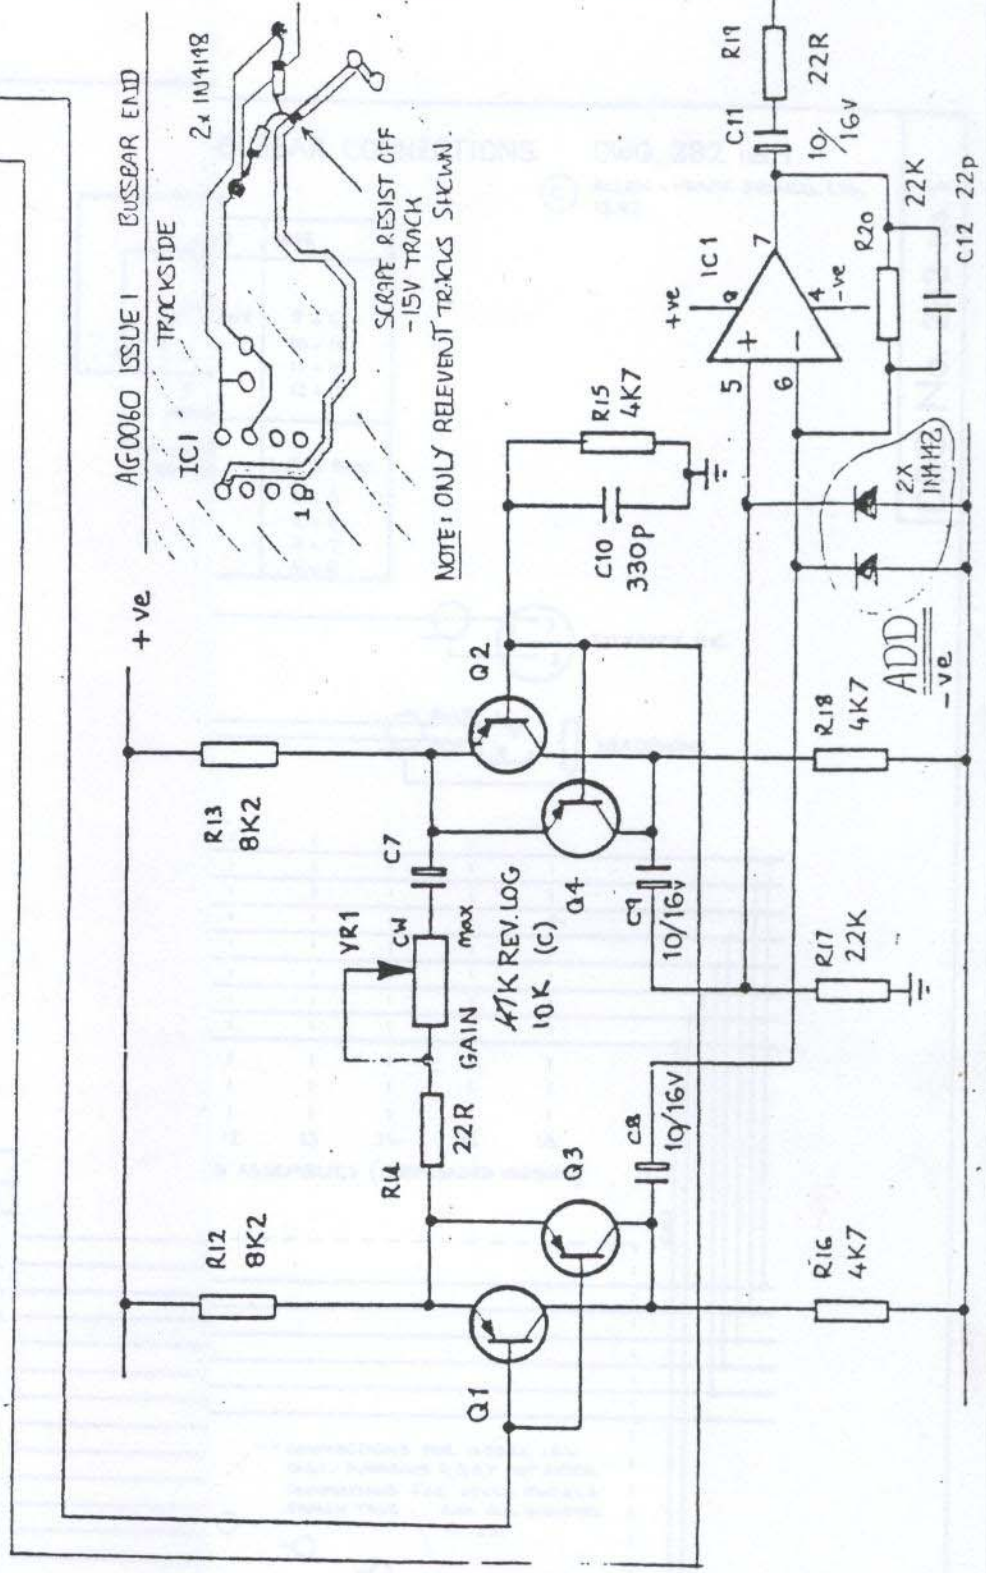
With a faulty microphone input connector that earths pin 2 or pin 3 of the channel input and when the +48 volt phantom power is on, failure of the IC1 on the input pcb can occur at the moment the connector is inserted. Experience is that only a small percentage of channels will fail, and the following makes the preamp proof against this failure condition.

Open the unit and on input pcbs locate the input pins to IC1 TLO72CP

pins 5+6

pins 2+3

Parts required: 2 off general purpose silicon diode IN4148 or equivalent.

Add one diode between each input pin and the negative 15 volt supply as shown on the diagram. Observe the diode polarity, the end with the stripe should connect to the IC input pins.

This revision applies to all production to date and is factory fitted on System 8 units after serial number 1100 and Series 21 units after serial number 0436.
